ASSOCIATION OF VILLAGE COUNCIL PRESIDENTS

# Public Safety FACILITIES ASSESSMENT

Summer of 2018

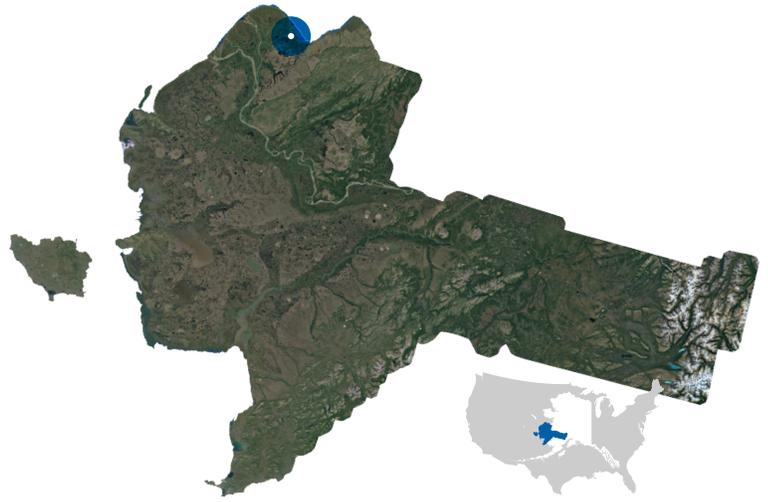
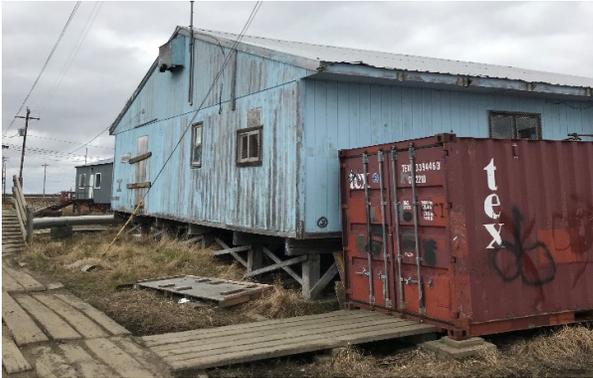
1. Broken window
2. Entrance Door
3. Exit Door

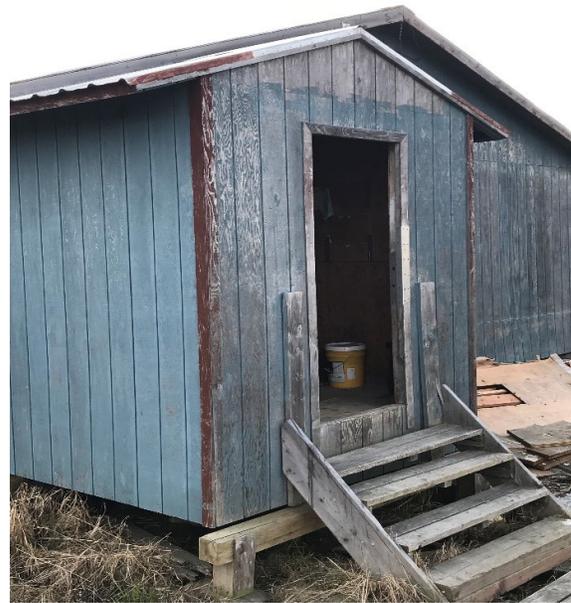
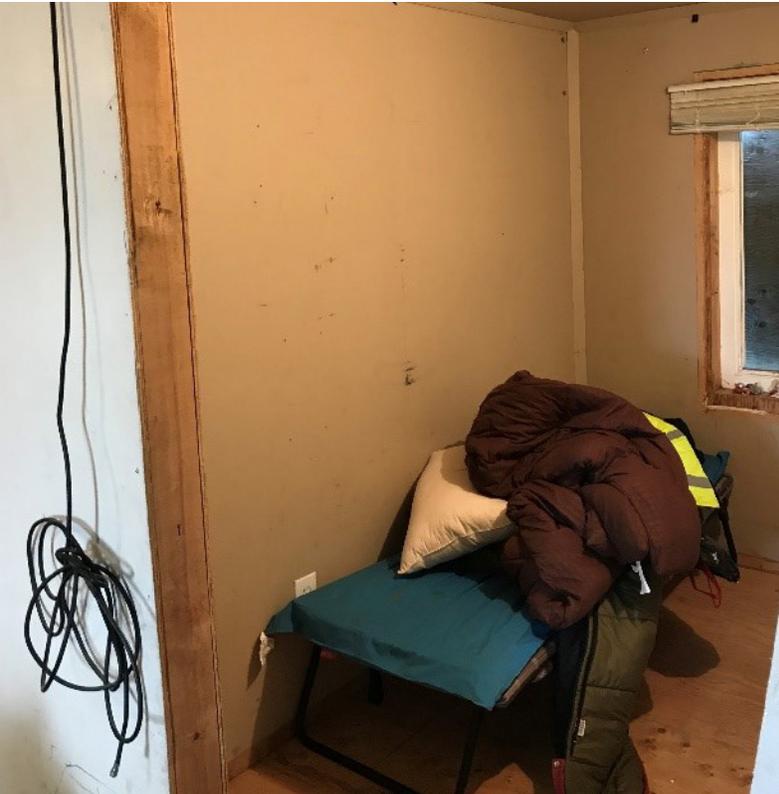
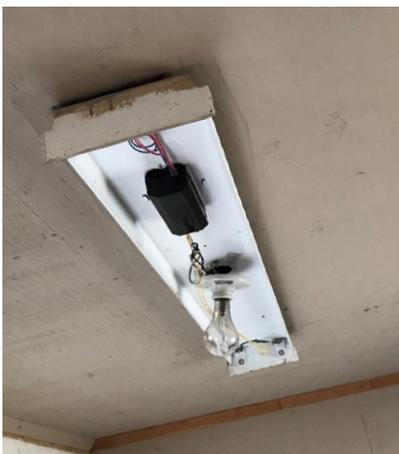
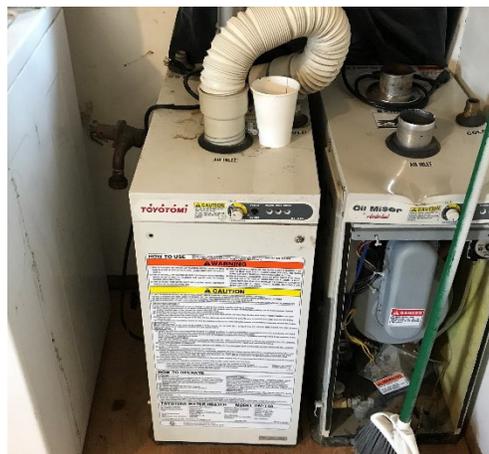
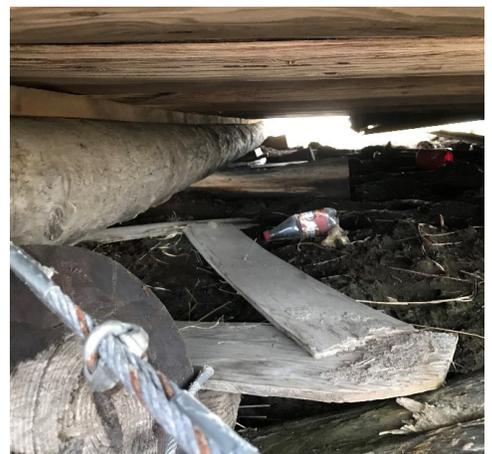
1. Raise building above flood level
2. Doors missing at bedrooms
3. Light Fixture Repair
4. Install flooring
5. Heating system service and repair

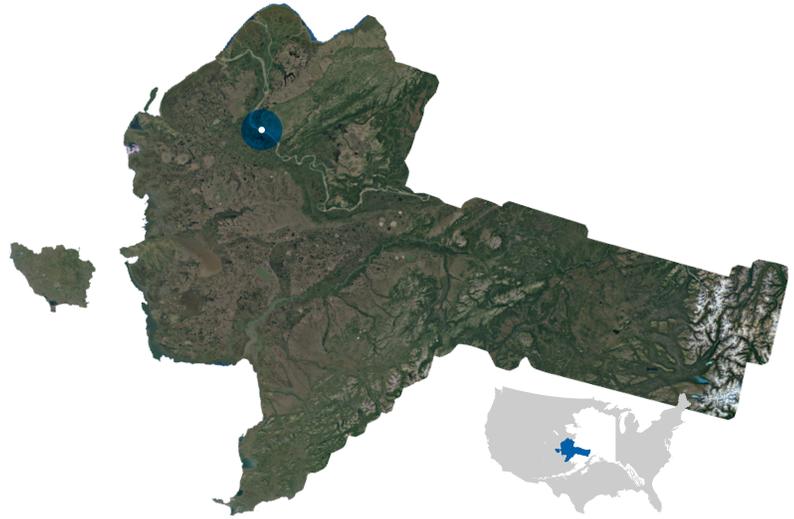
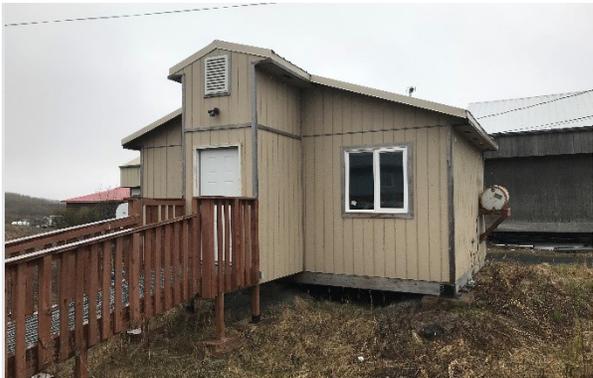
1. Broken window

Public Safety Office and Jail currently located at City Offices. New Facility is built but needs to be relocated due to being constructed over city utilities.

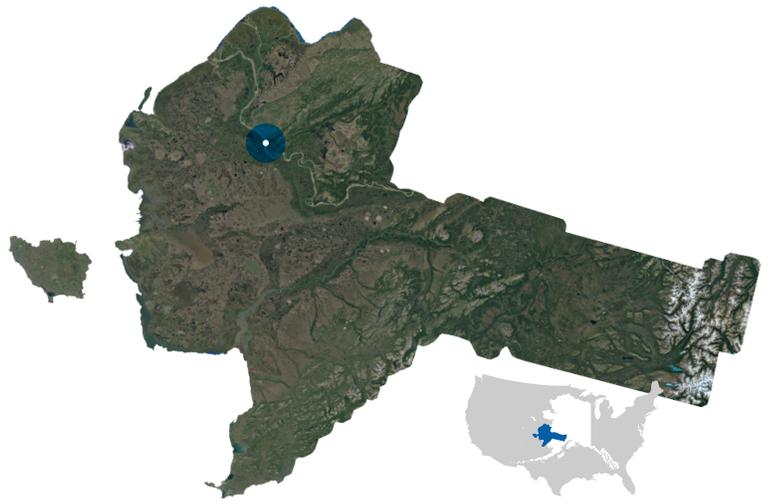
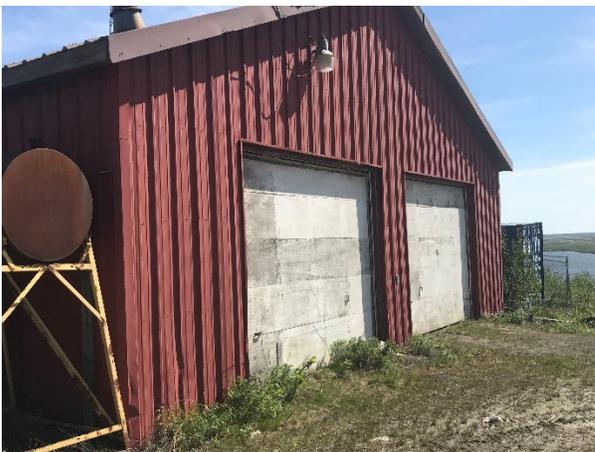
Building used is the city's old fire station and needs remodeling or replacement.

- 1. Furnace
- 2. Front door
- 3. Broken window

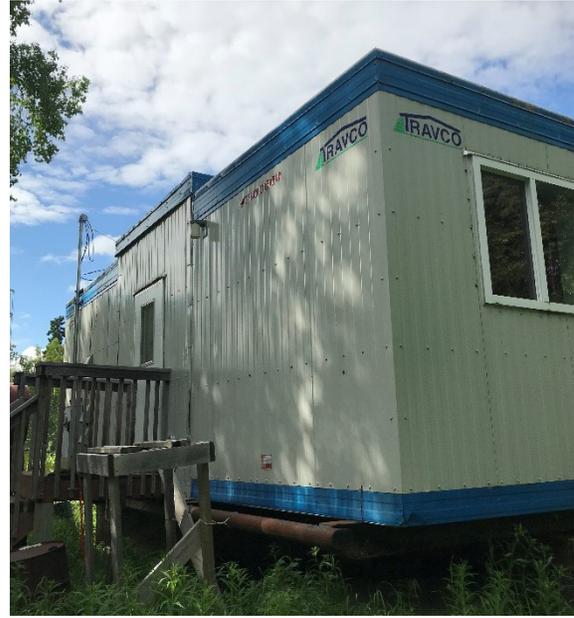
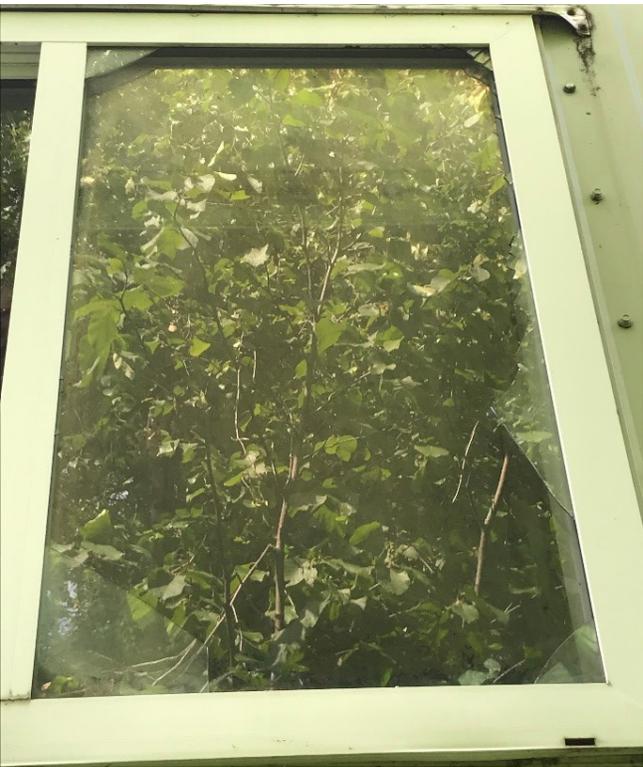
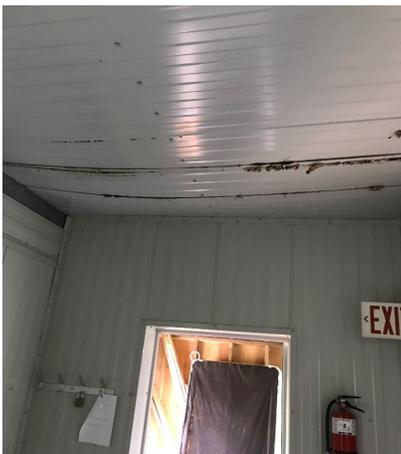
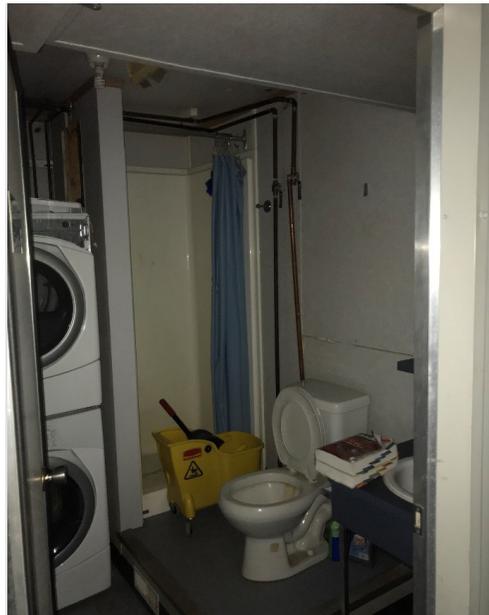
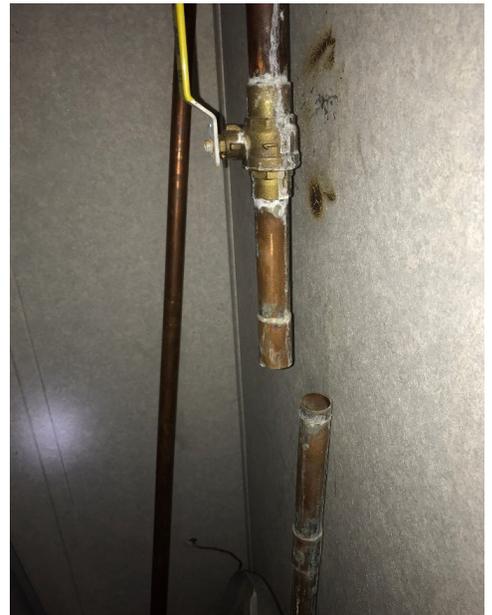
1. Roof leak
2. Water and sewer
3. Broken window

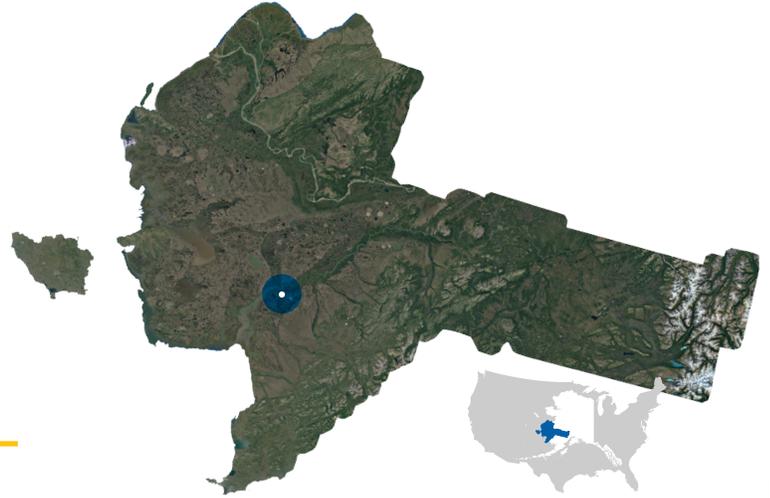
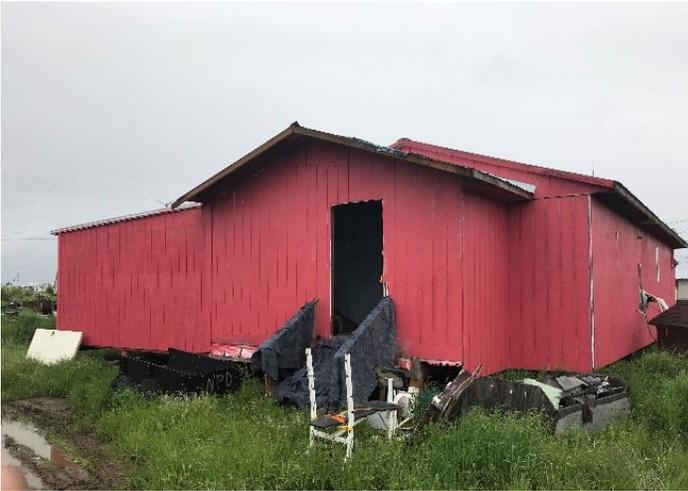
1. Front and back doors were set on fire
2. Foundation
3. Entry steps

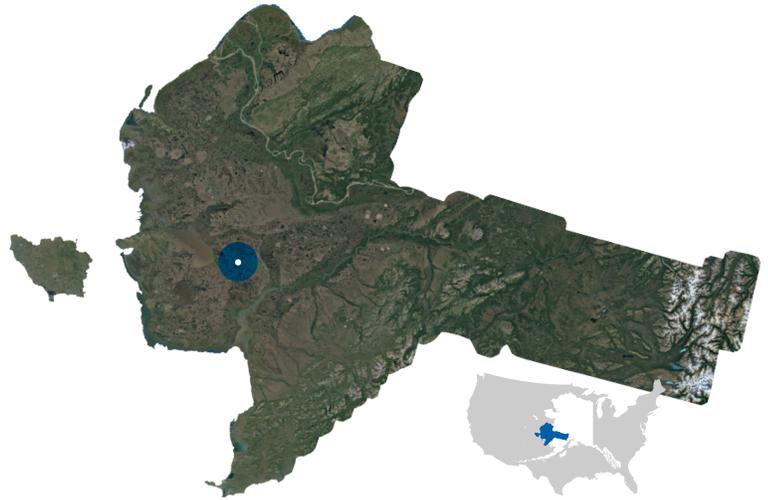
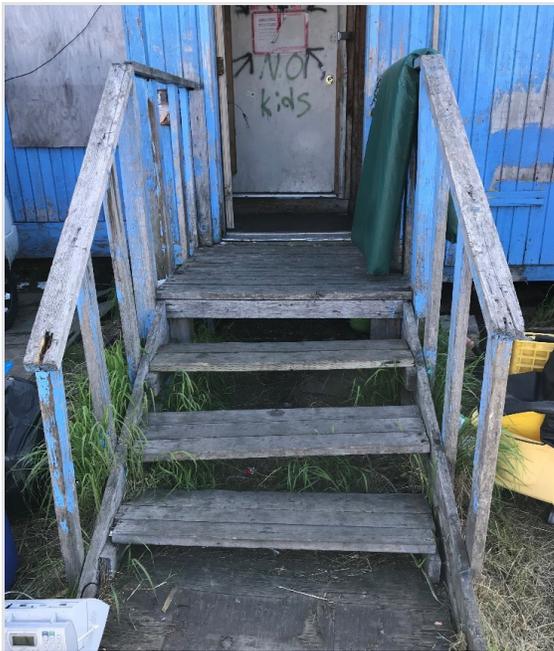
1. Window
2. Flooring
3. Chimney
4. Entry Stairs
5. Fuel leak

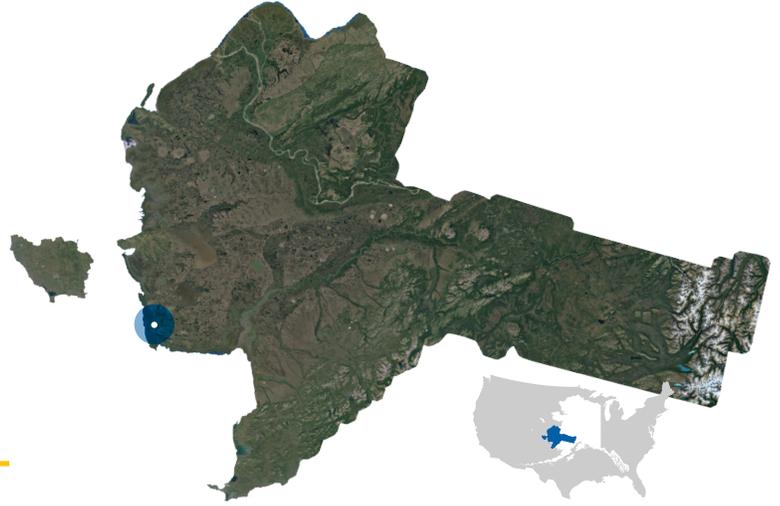
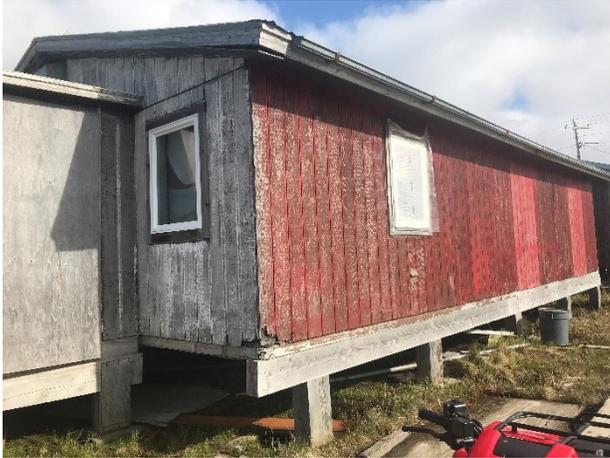
1. Foundation
2. Broken windows
3. Meter base service wire

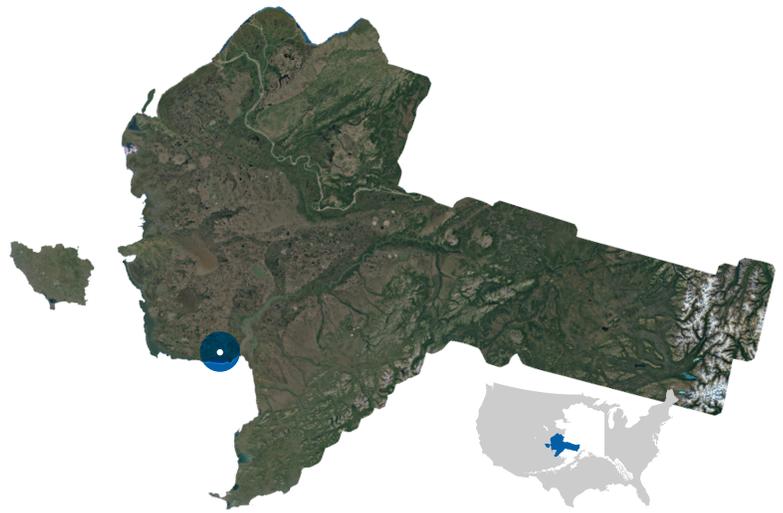
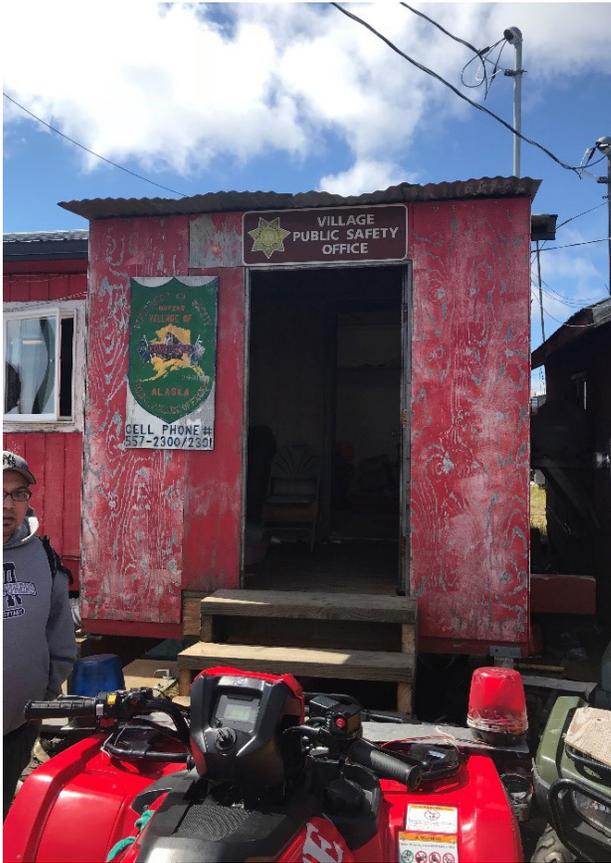
1. No Heat
2. No Running Water
3. Broken Windows

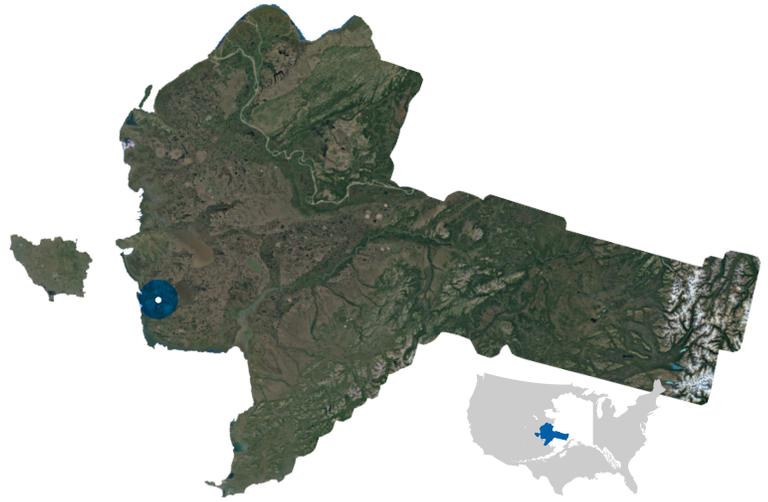
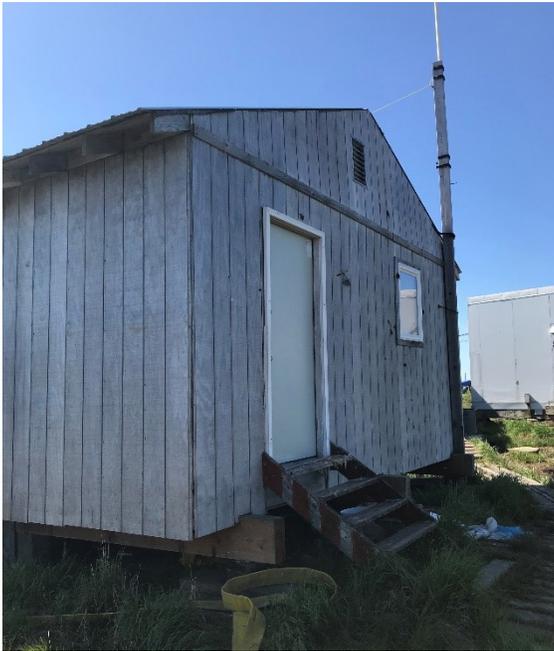
1. Electrical panel/meter base
2. Plumbing
3. Front entrance deck and stairs
4. Broken window

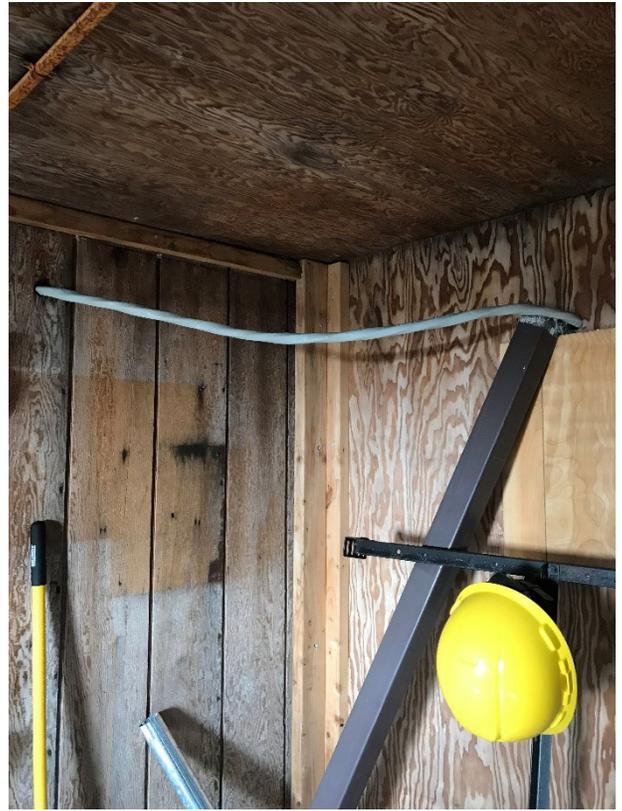
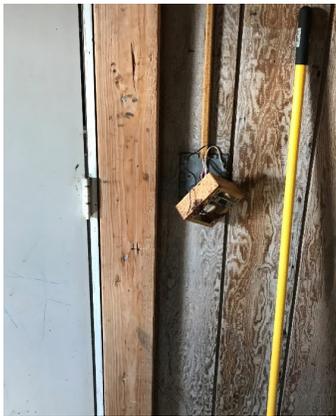
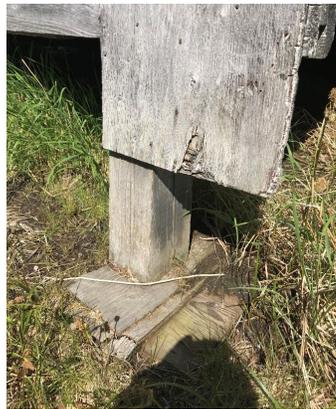
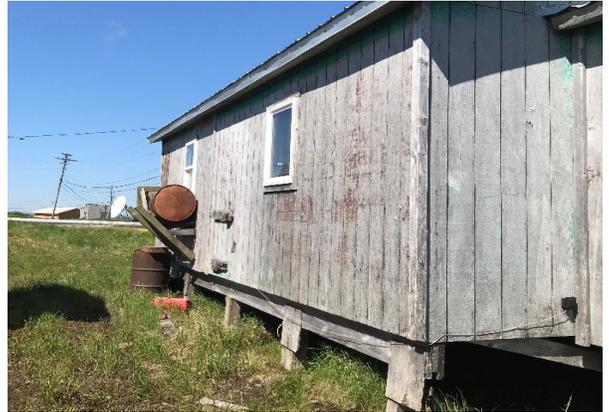
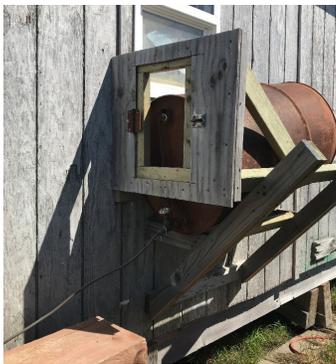
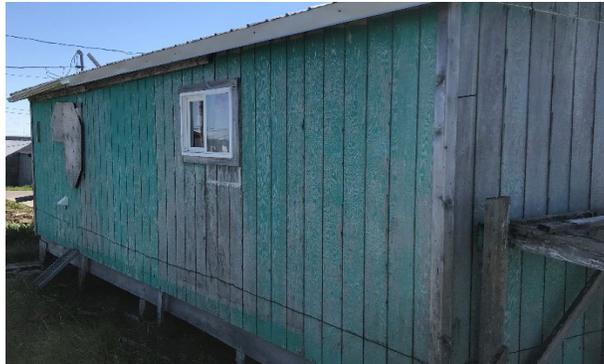
1. Exposed electrical wire
2. Foundation
3. Fuel tank stand
4. Missing chimney cap

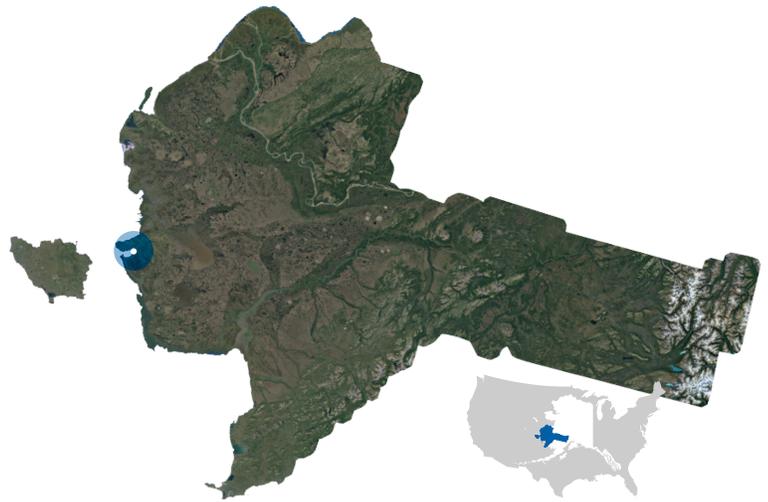
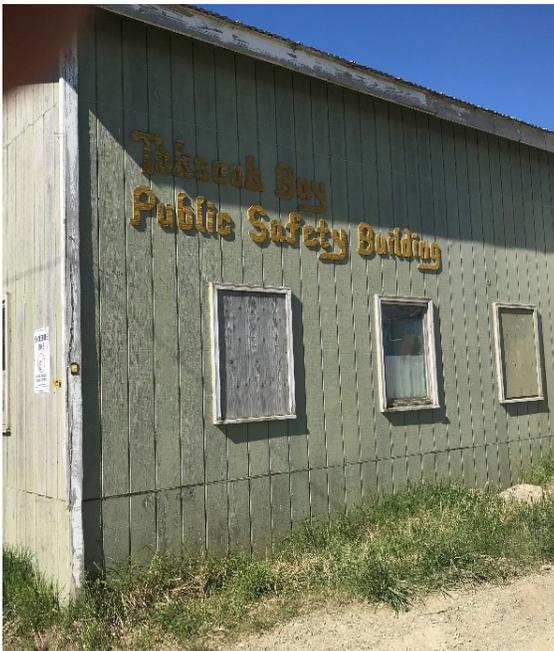
1. Broken Window
2. Electric service
3. Entrance broken
4. No plumbing

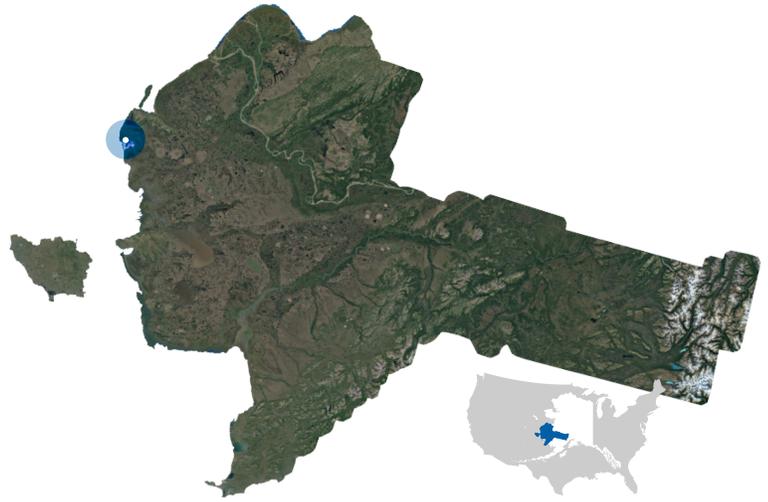
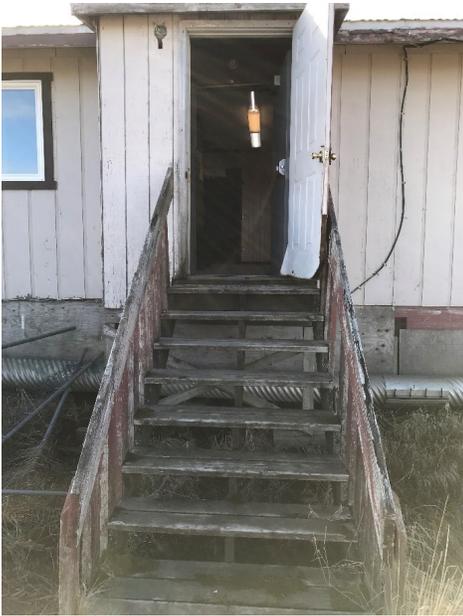
1. Sewer line replacement
2. Miller Furnace (Heater) maintenance
3. Broken windows and doors
4. Replace rear entry steps
5. Foundation level, repair, and/or replacement

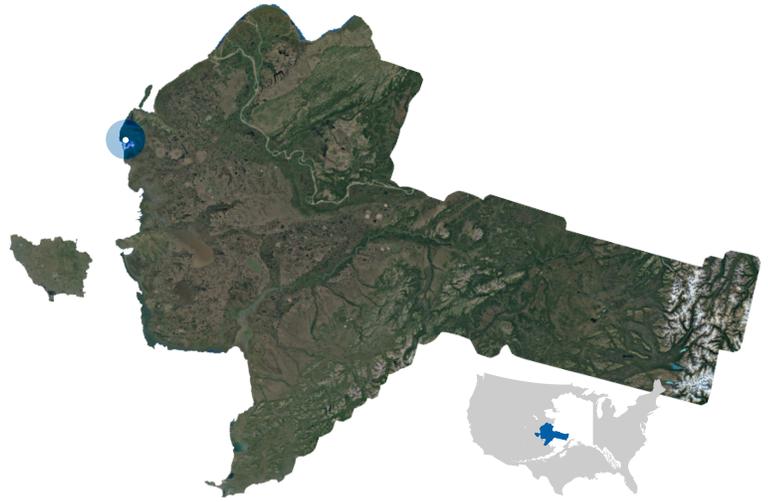
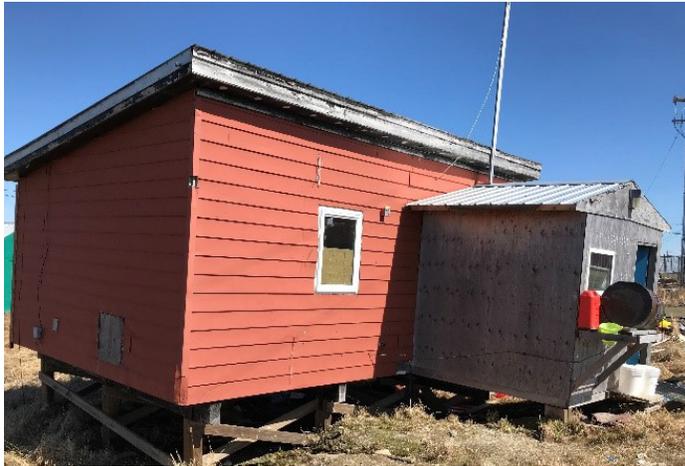
1. Level/Replace Foundation
2. Inadequate Size for Personnel and Equipment
3. Electric Unit Heater Hazard
4. Building Separating at prior addition
5. Broken Windows

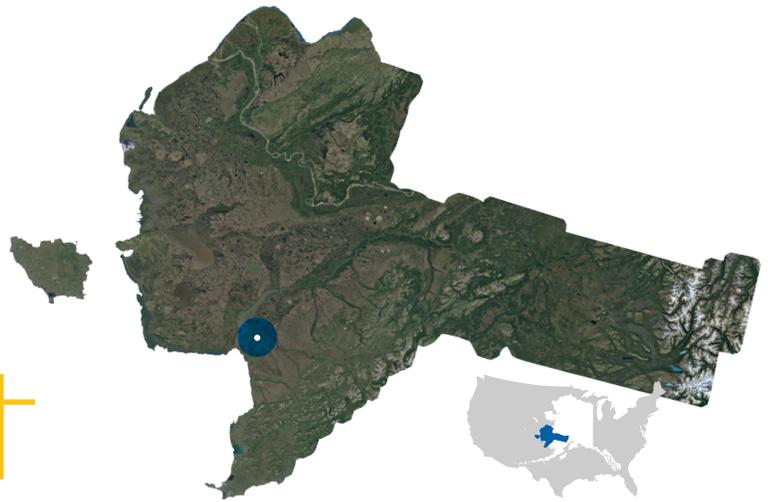
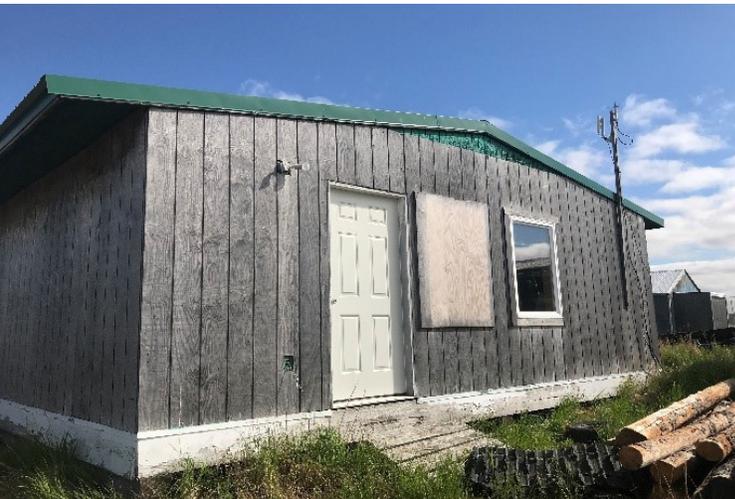
1. Foundation
2. Uninsulated floor
3. Broken window

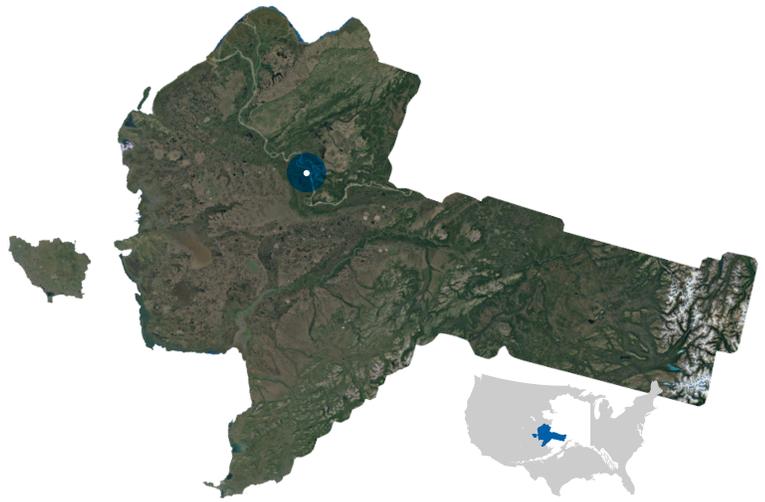
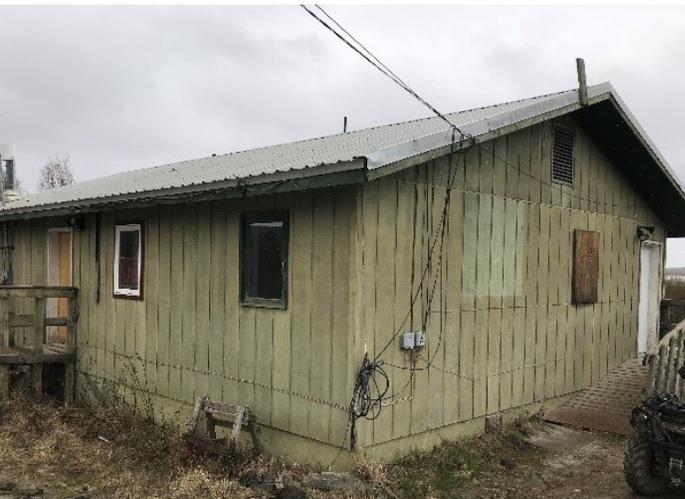
1. Broken/missing windows
2. Broken/missing doors
3. Repair/replace Exterior Handrails
4. Needs finish flooring

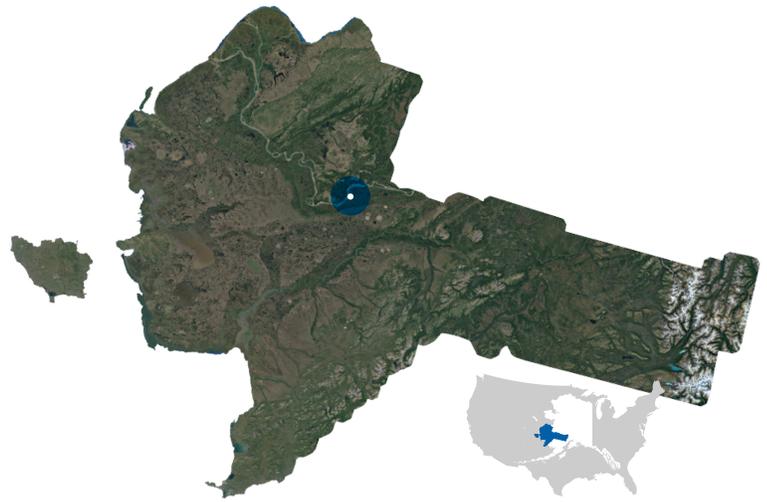
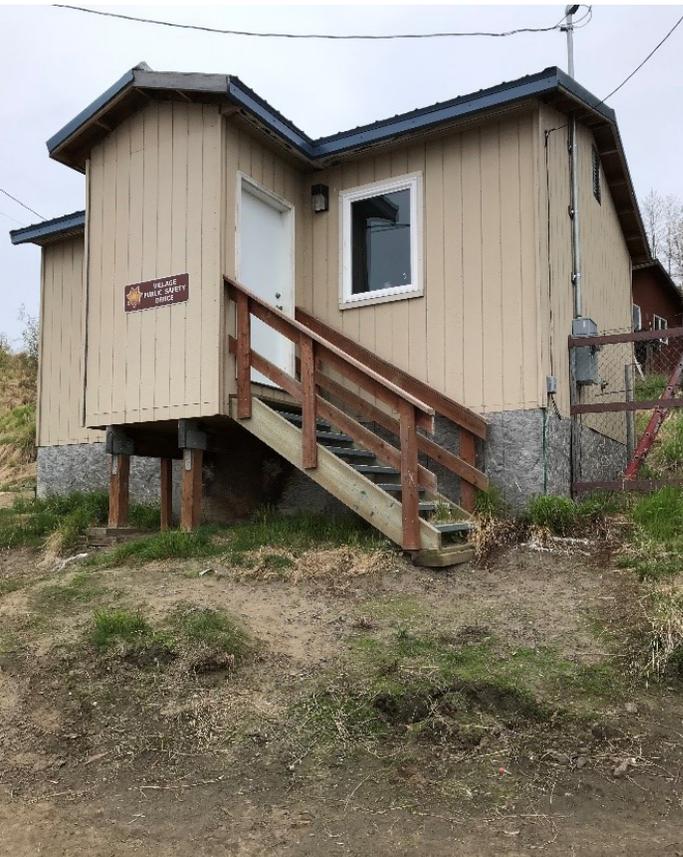
- 1. Gable End Metal Missing

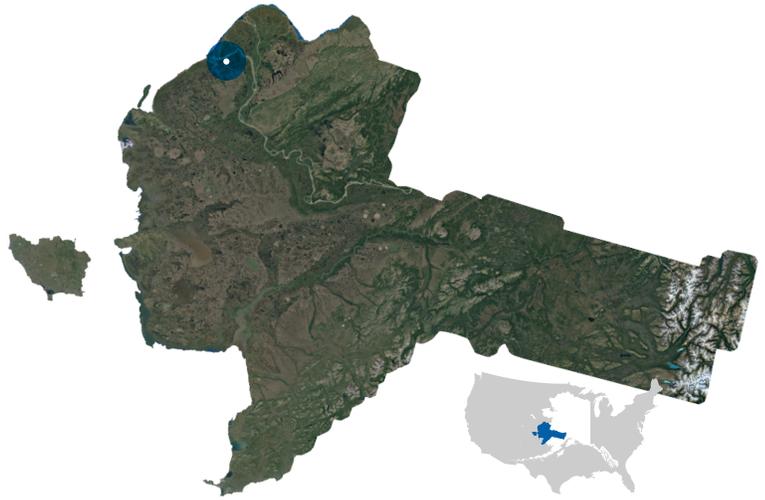
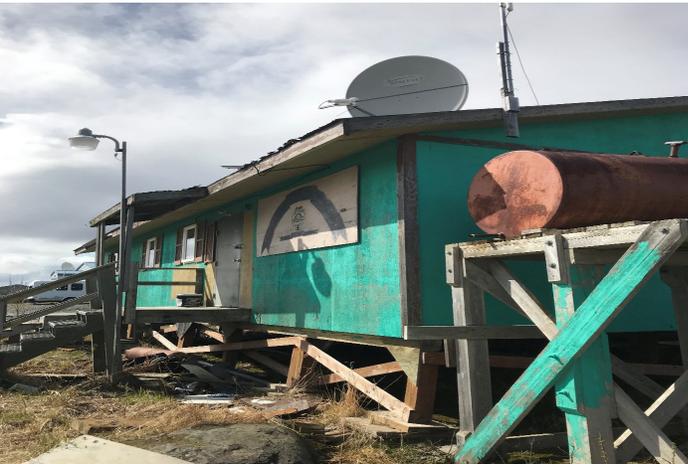
1. Heater Repair/replace
2. Foundation repair/replace
3. No running water
4. Leaking fuel line
5. Soffit missing
6. Broken Windows and Doors
7. Electrical Panel Service and Cover

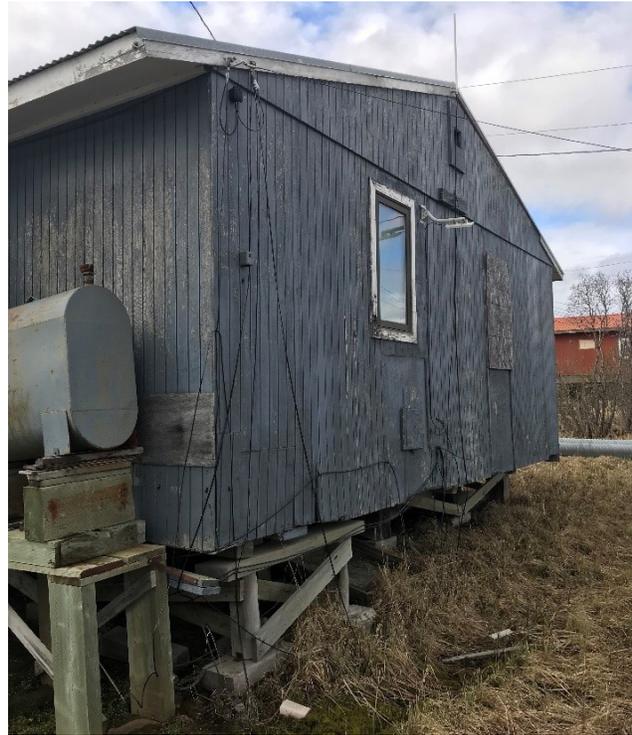
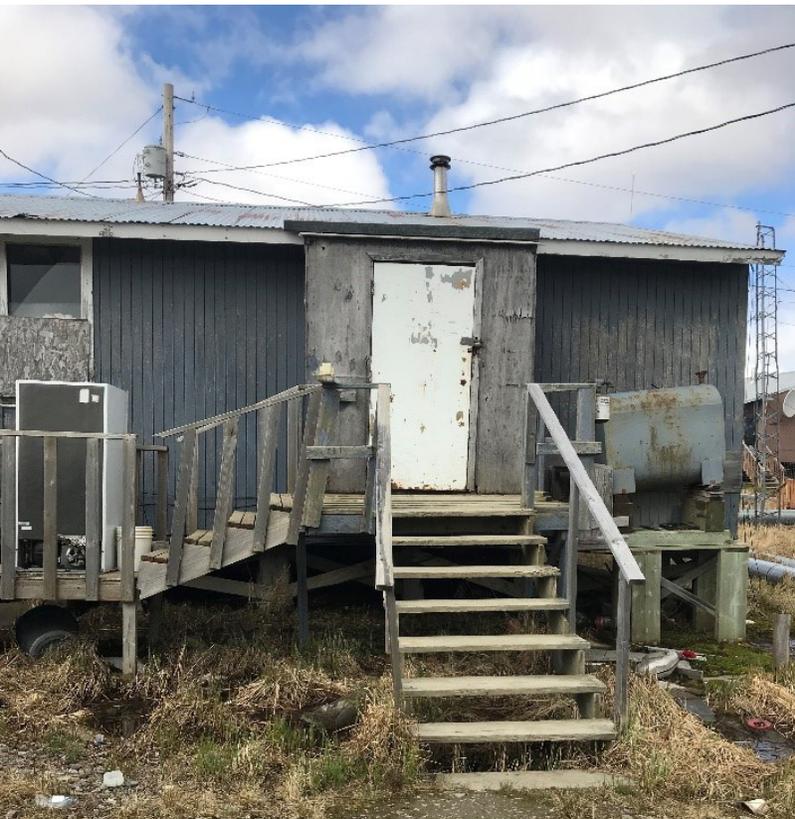
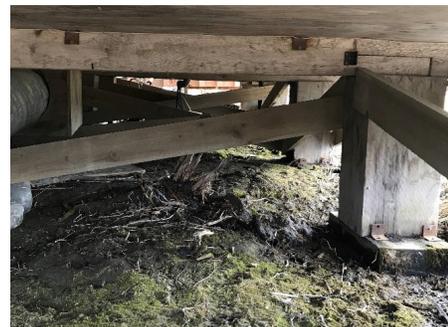
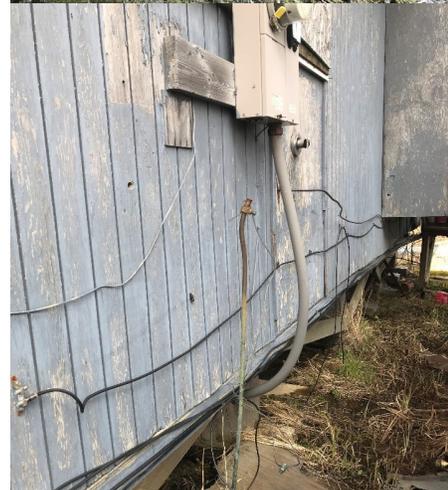
1. Front stairs and deck
2. Windows broken
3. Ground Rod
4. Foundation

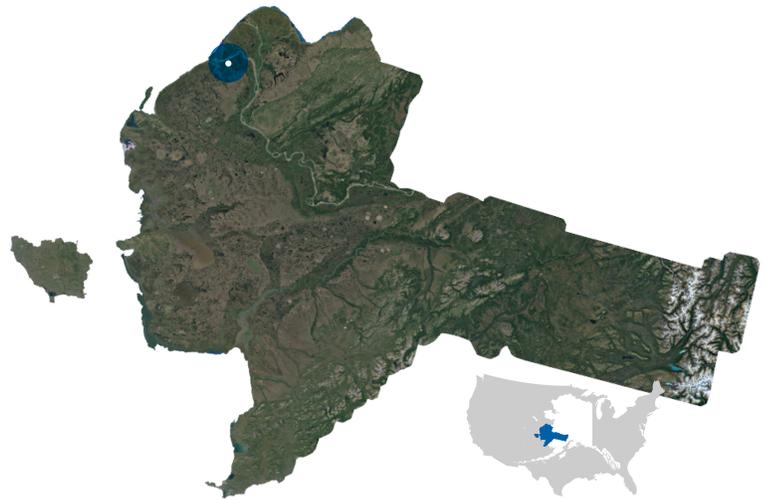
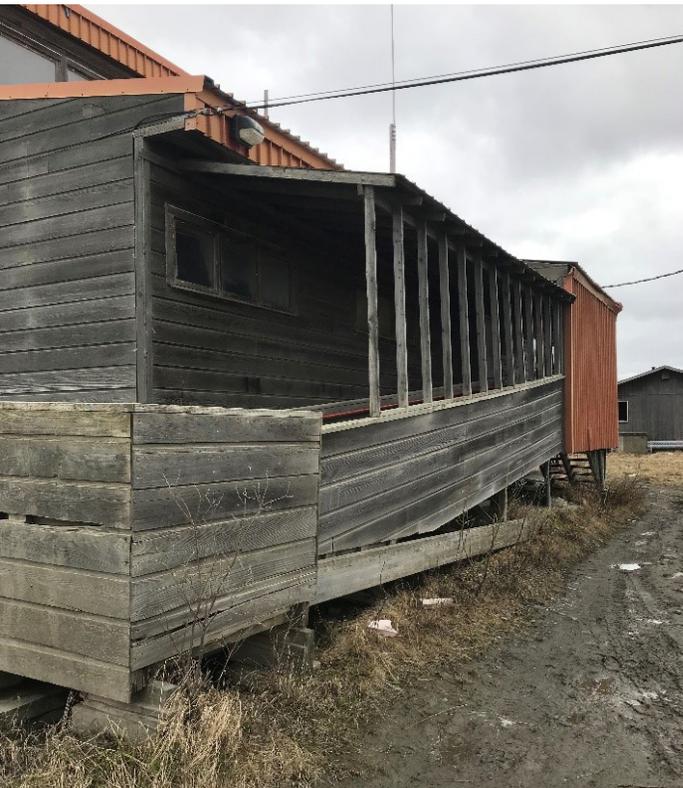
1. Broken front door glass
2. Exterior paint

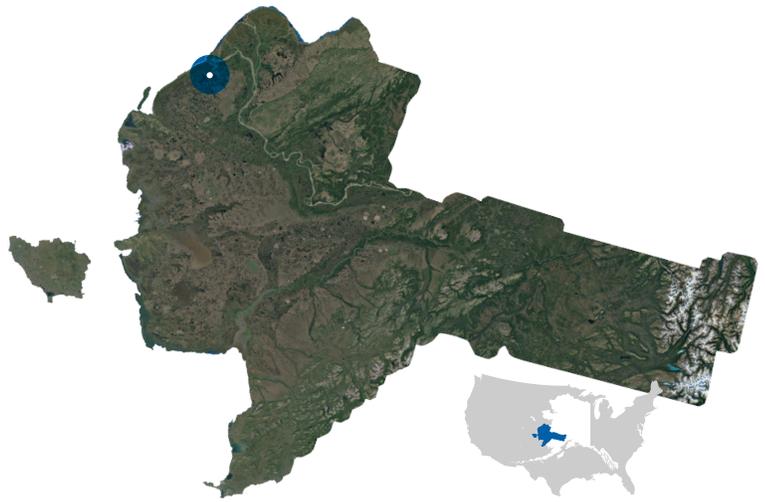
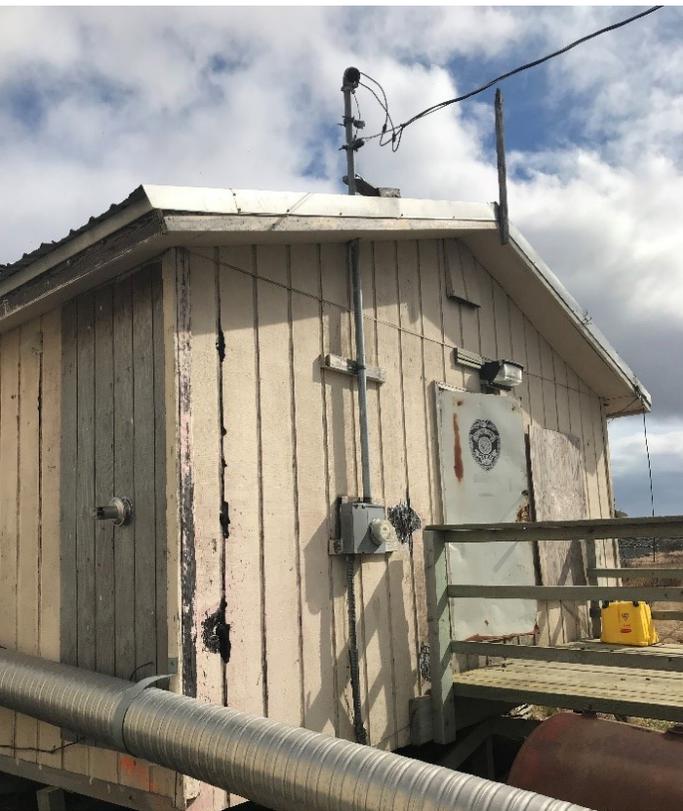
1. Mold and Foul Odor
3. Extensive water damage
4. Foundation and Stairs
