ASSOCIATION OF VILLAGE COUNCIL PRESIDENTS

# Public Safety FACILITIES ASSESSMENT

Summer of 2018

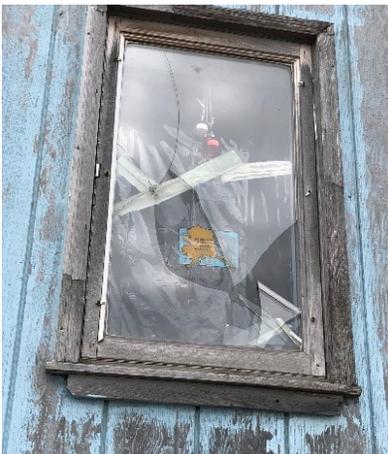
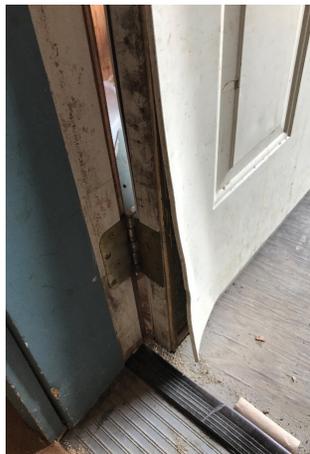
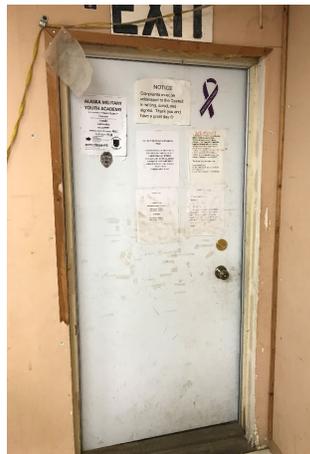
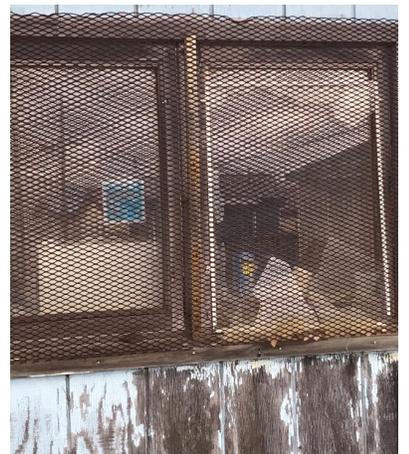
1. Broken window
2. Entrance Door
3. Exit Door

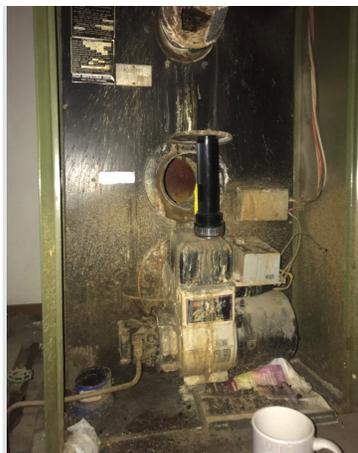
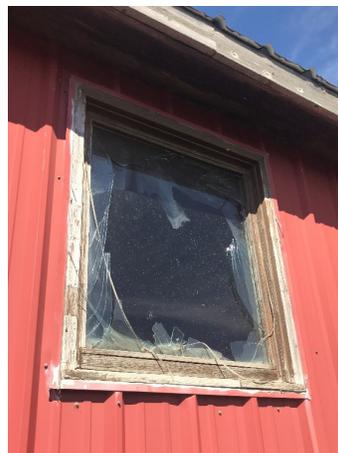
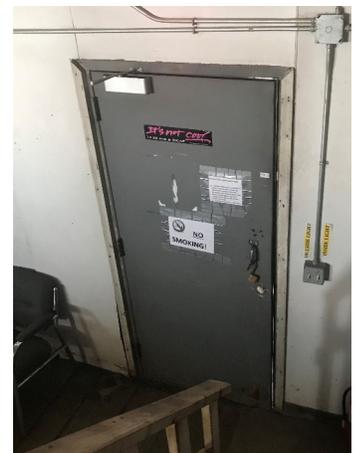
Building used is the city's old fire station and needs remodeling or replacement.

- 1. Furnace
- 2. Front door
- 3. Broken window

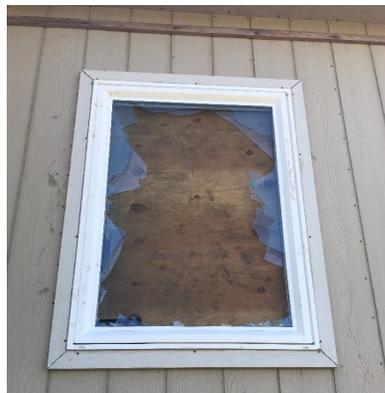
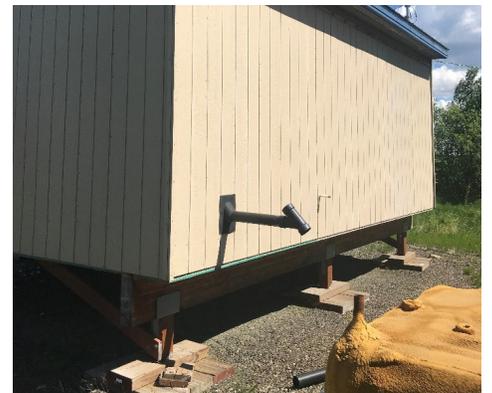
1. Broken Window
2. Hook up plumbing

12x16ft, needs reparis

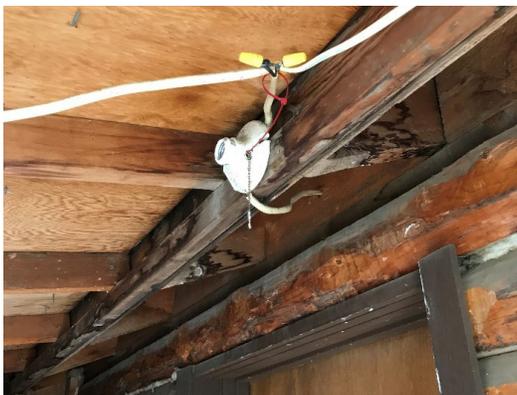
Needs improvments

1. Foundation
2. Back door blocked
3. Poor lighting
4. Window

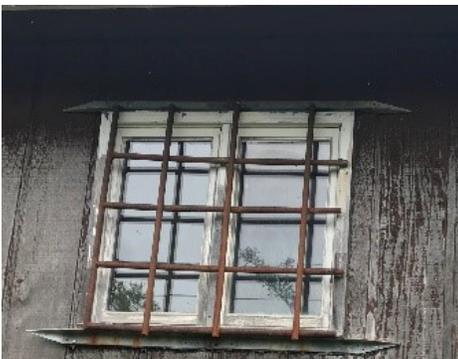
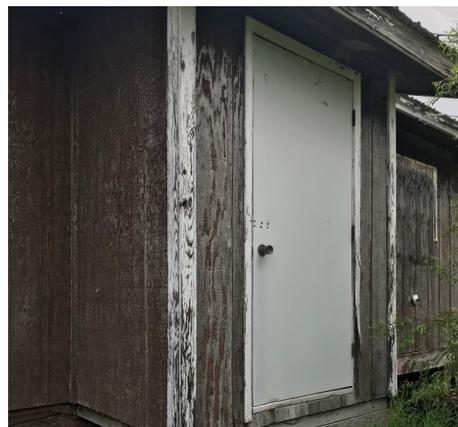
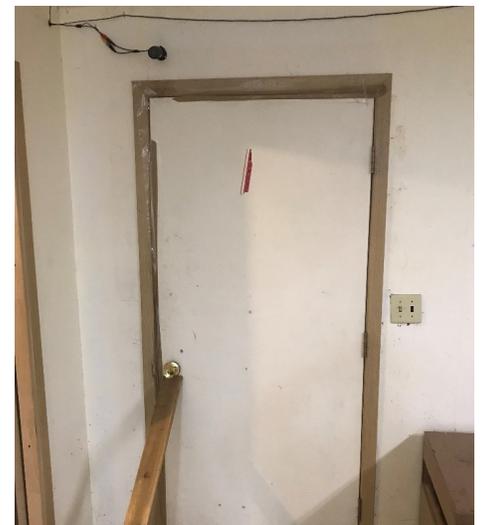
1. Window
2. Door lock
3. Exterior stairs

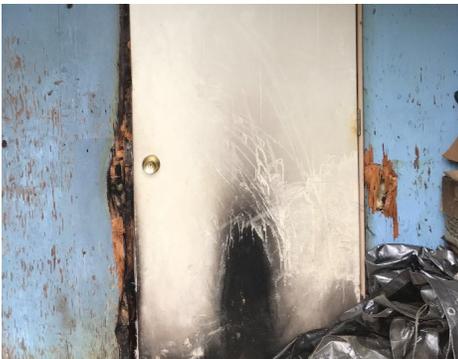
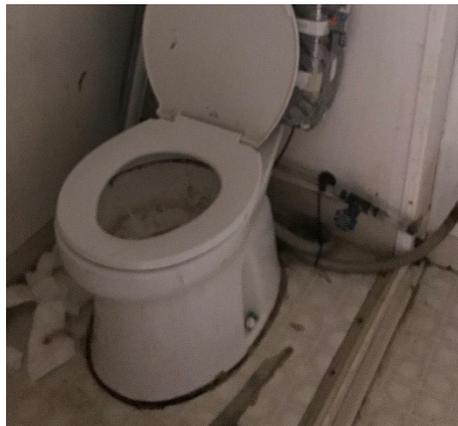
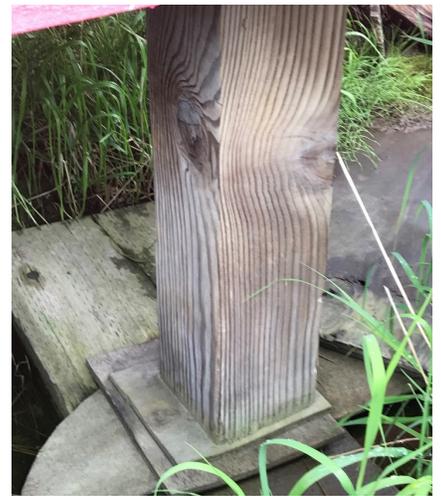
1. Front and back doors were set on fire
2. Foundation
3. Entry steps

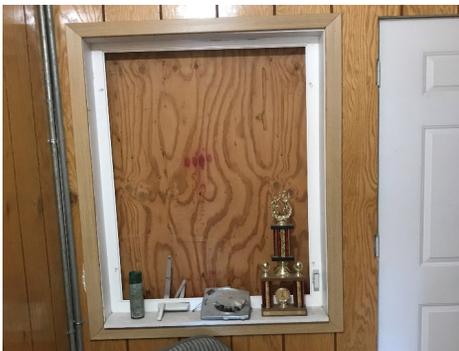
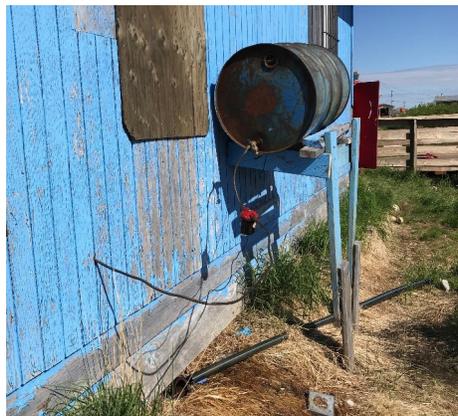
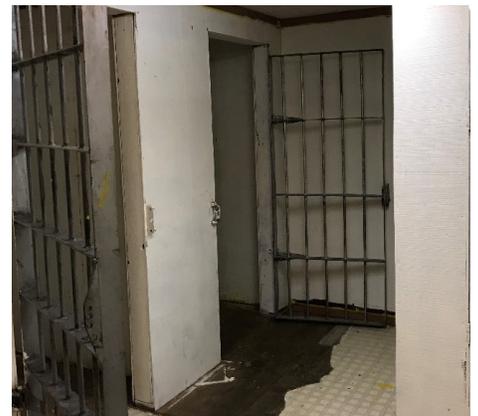
1. Window
2. Flooring
3. Chimney
4. Entry Stairs
5. Fuel leak

Wireless antenna should be utilized due to condition of building.

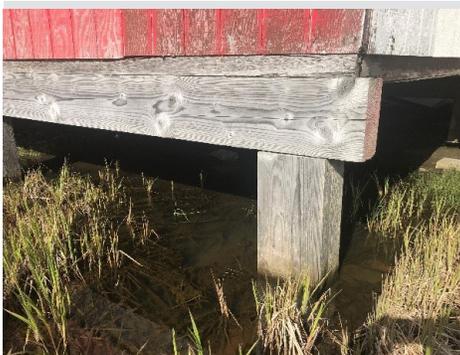
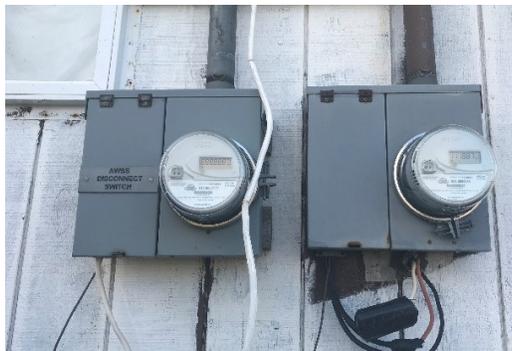
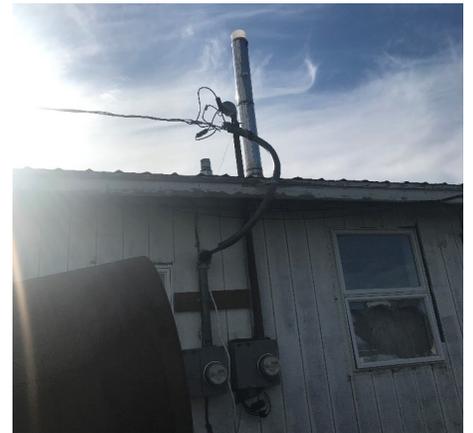
1. Foundation
2. Broken windows
3. Meter base service wire

Wireless antenna should be utilized due to condition of building.

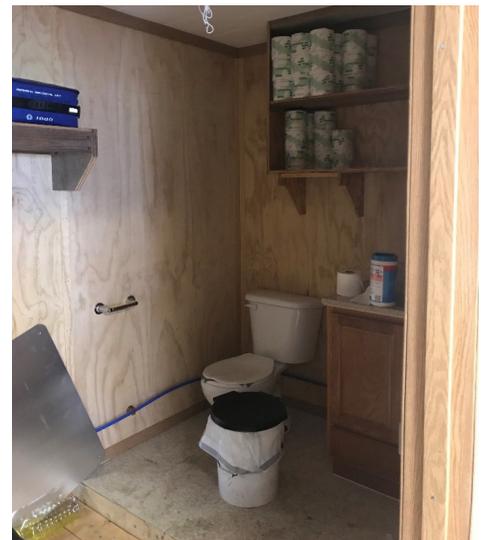
1. No Heat
2. No Running Water
3. Broken Windows

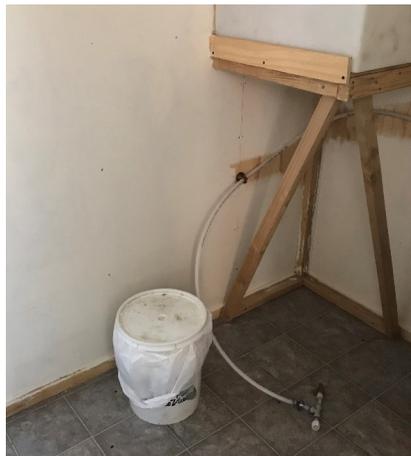
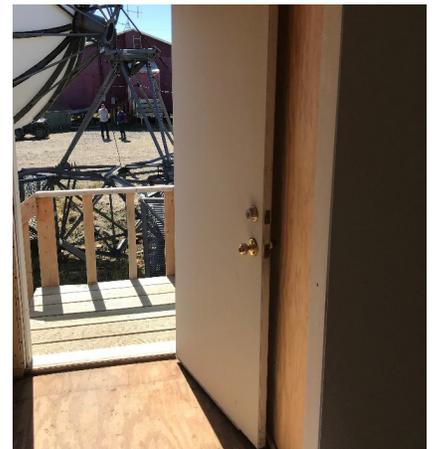
New building. Needs plumbing hooked up.

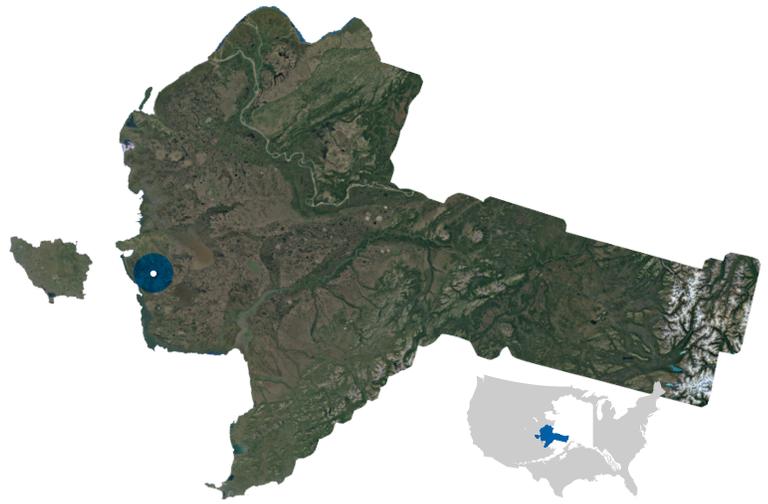
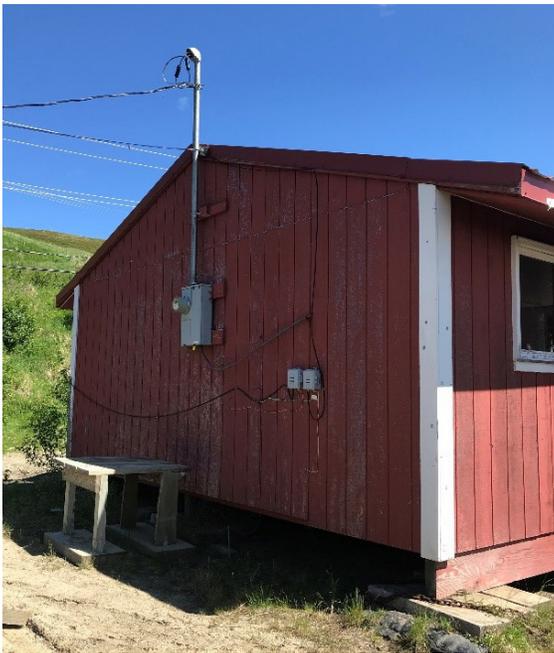
## NIGHTMUTE

1. No running water
2. No heat
3. Electrical panel/meter base service wire

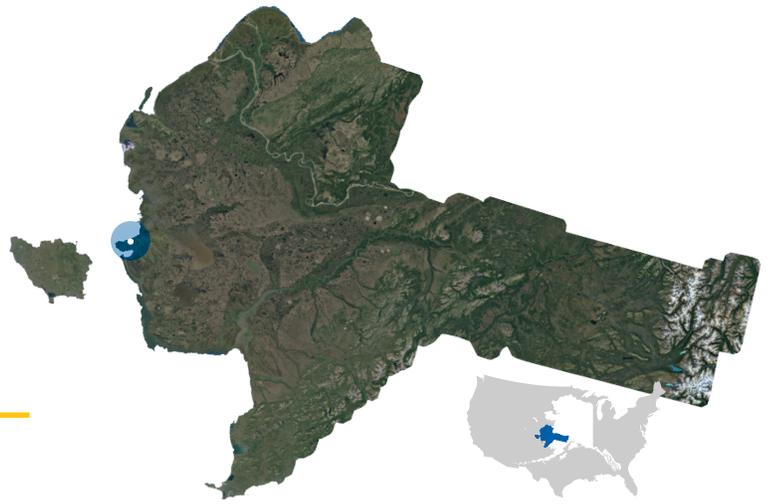
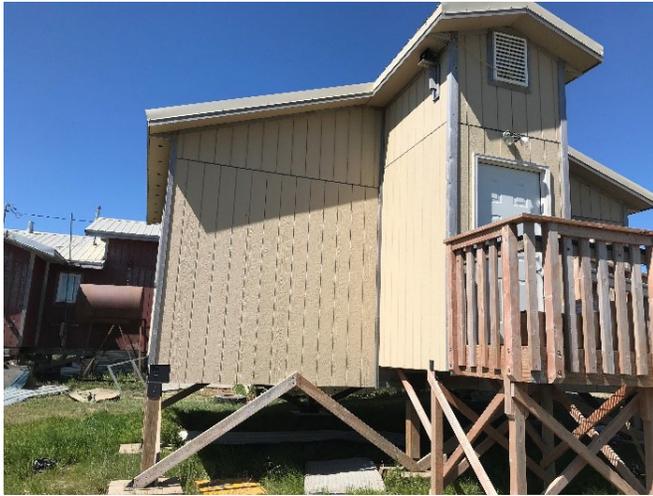
## TUNUNAK

New building. No one available for interior inspection.

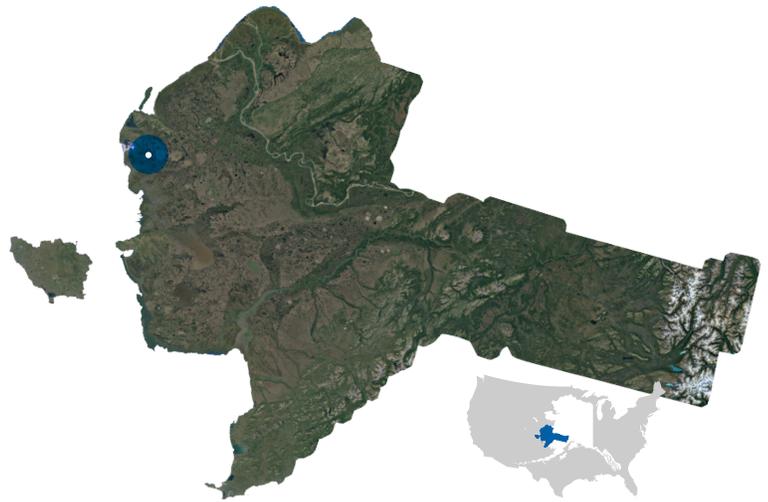
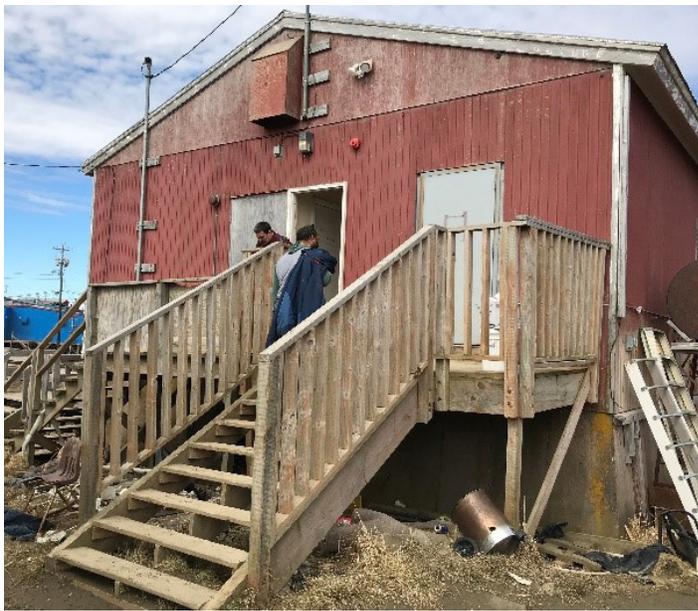
## CHEVAK

Renovated in 2011/12.

1. Boiler Service and/or Replacement (2 new boilers located in crates under building)
2. Electrical Panel Service and Repair
3. Exterior Hand Railing Repair

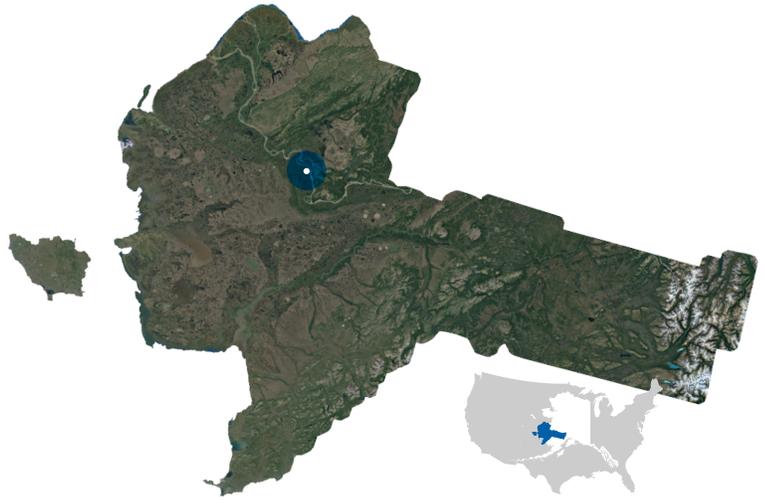
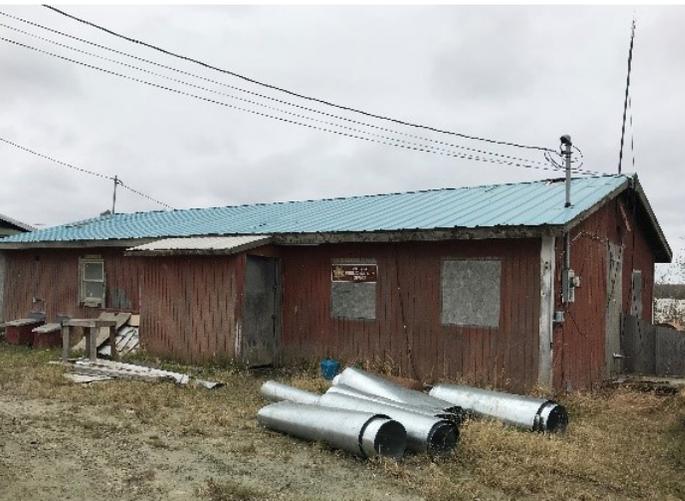
## MARSHALL

1. Broken/missing windows
2. Foundation Repair/Replace
3. Roof Metal Repair/Replace
4. Electrical Hazards
5. Heater Service/Replacement

The police department looked to be abandoned, there was a cable modem, which was probably their internet connection. Did not see wireless antenna.

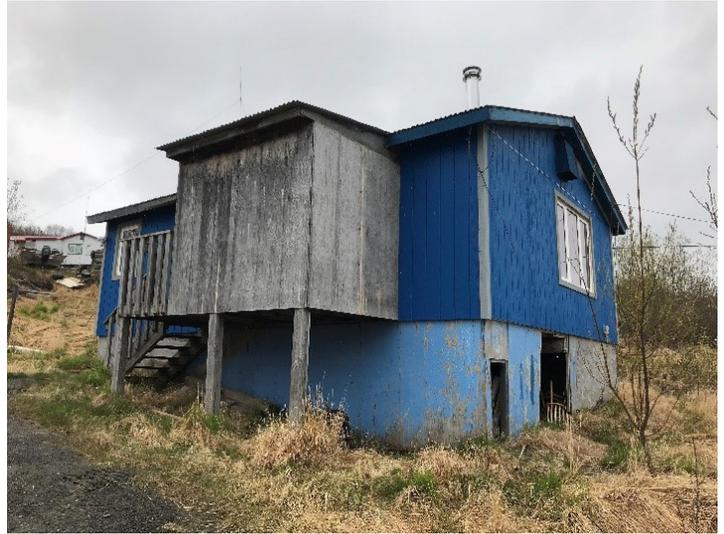
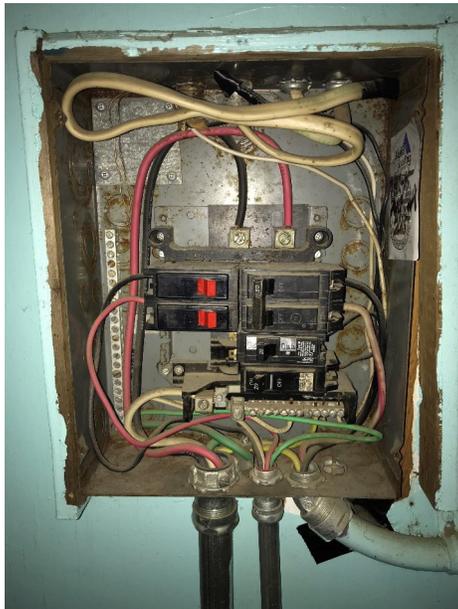
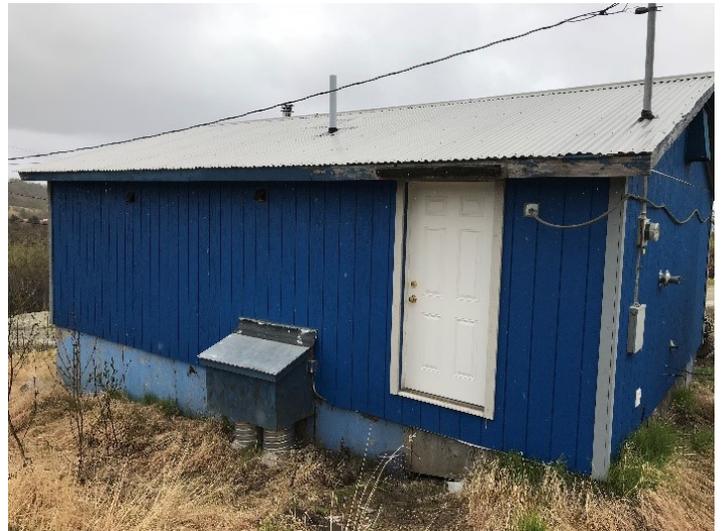
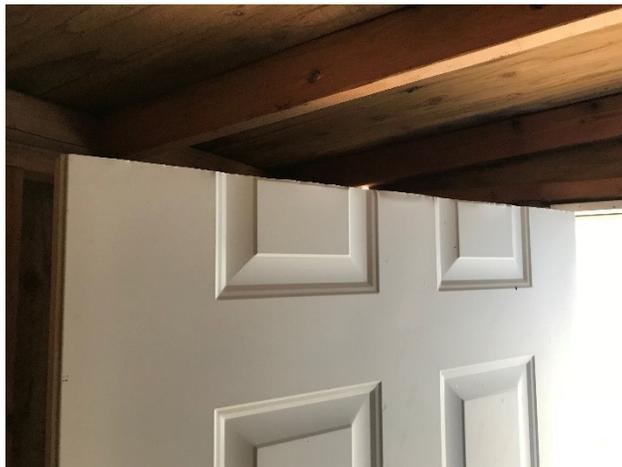
## PILOT STATION

1. No stairs at second exit
2. Electrical Panel Cover
3. Entry Door Finish

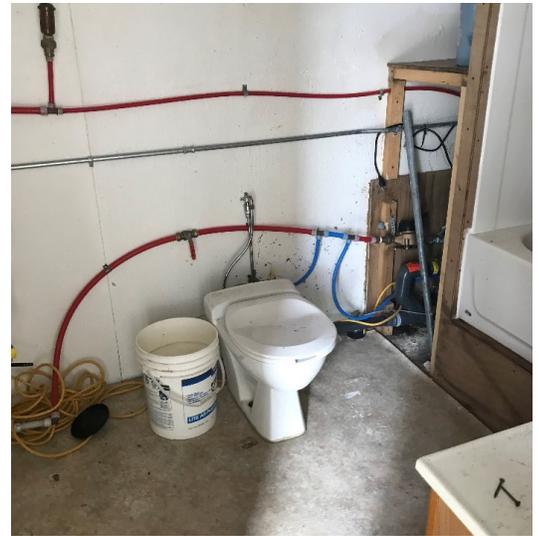
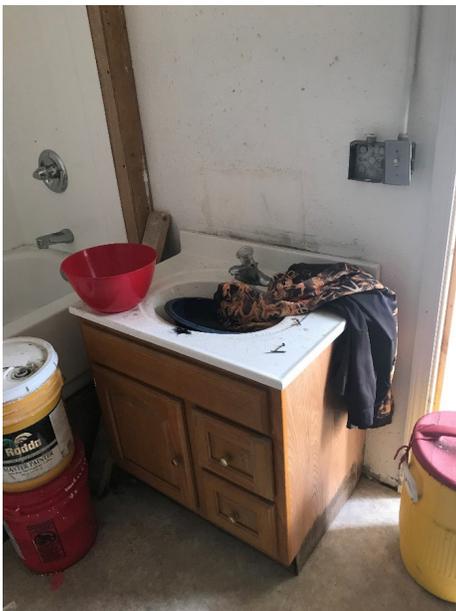
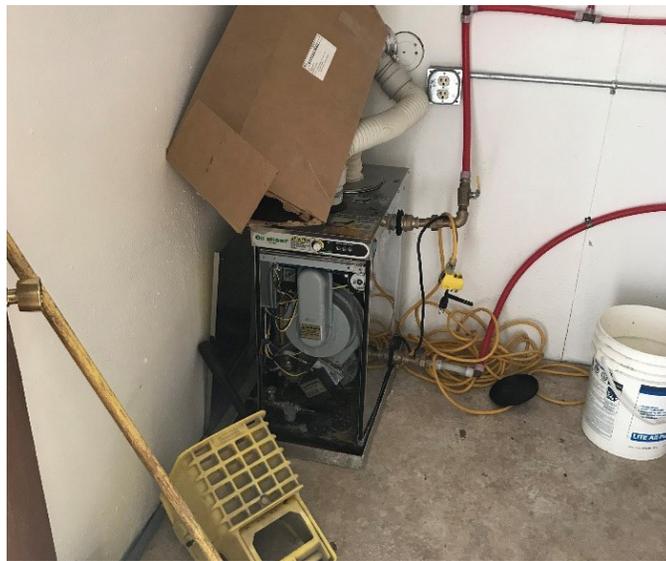
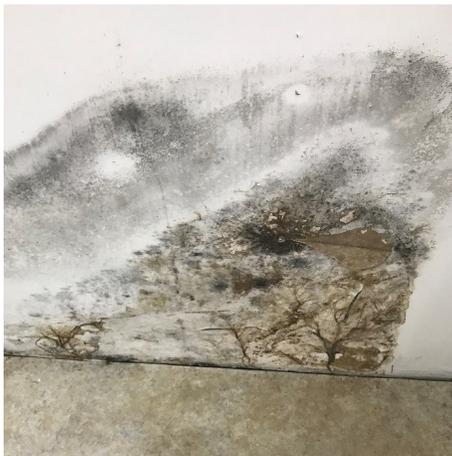
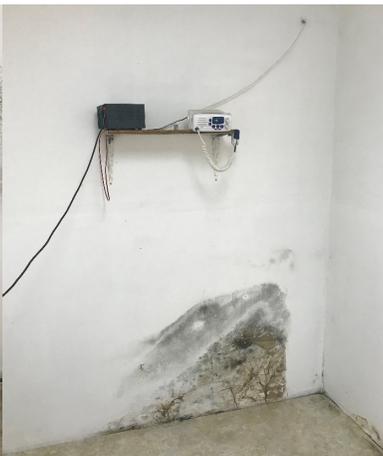
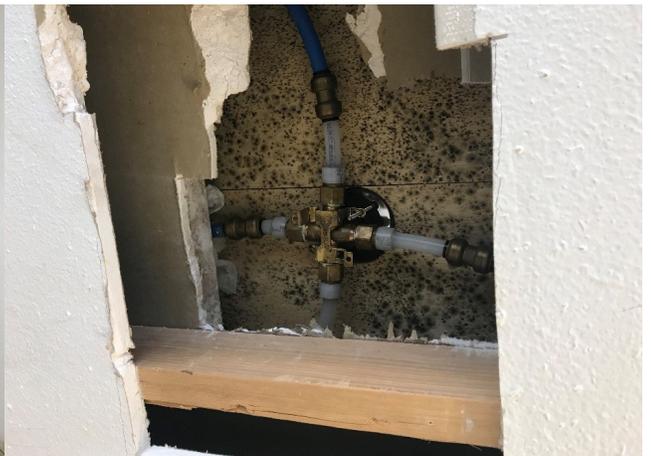
## NUNAM IQUA

1. Mold and Foul Odor
3. Extensive water damage
4. Foundation and Stairs
